Test Report No: WTH Corrosion 1

Testing of: Various locking systems

Tested to: BS EN 1670:2007 Building hardware. Corrosion resistance  
Requirements and test methods

Prepared for: Nico Manufacturing Ltd

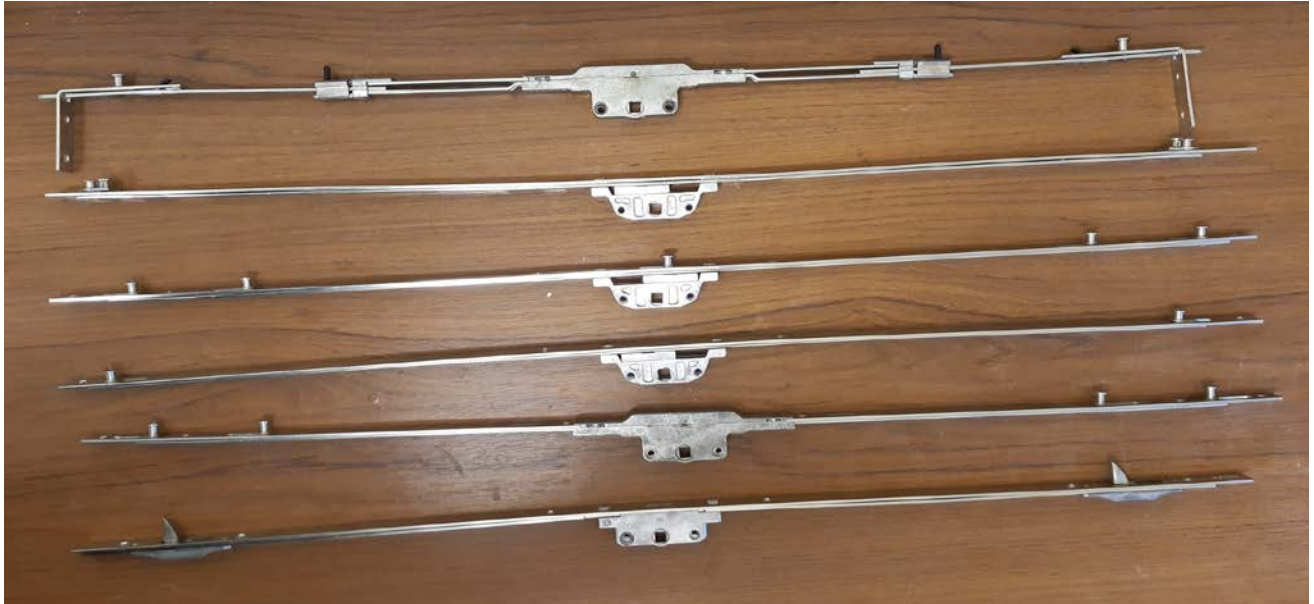
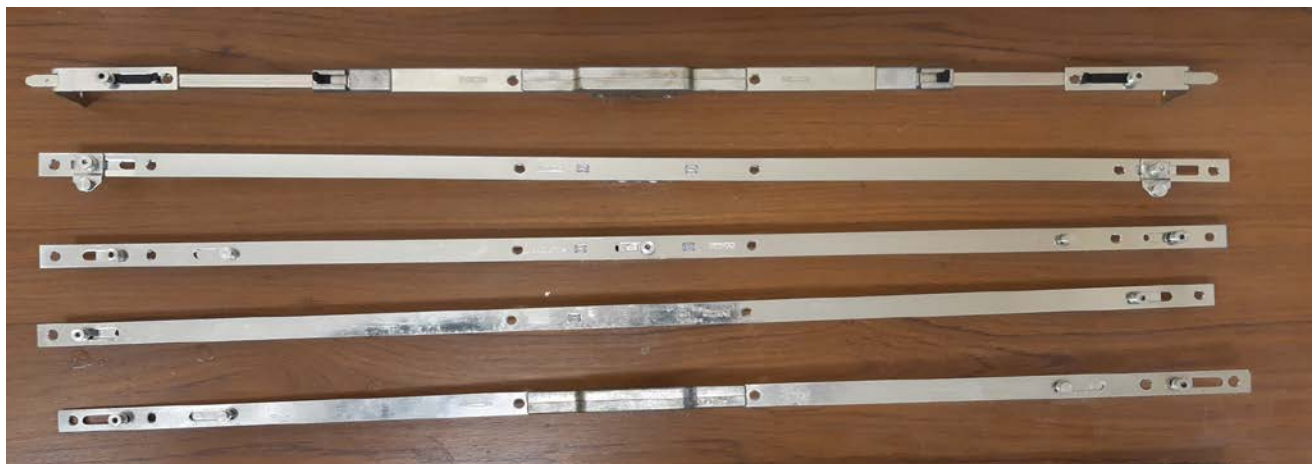
**Samples pre-test**

Item Description	Part number	Finish
Nico Espagnolette	98822S5	Supercoat 500
Nico Multilock Security Espagnolette	918822S5	Supercoat 500
Nico Security Espagnolette	92751S5	Supercoat 500
Nico RAM Bolt Bi-directional Security Espagnolette	958822S5	Supercoat 500
Nico Retractable Espagnolette	967420	Supercoat 500
Nico Telescopic Shootbolt	9786822	Supercoat 500

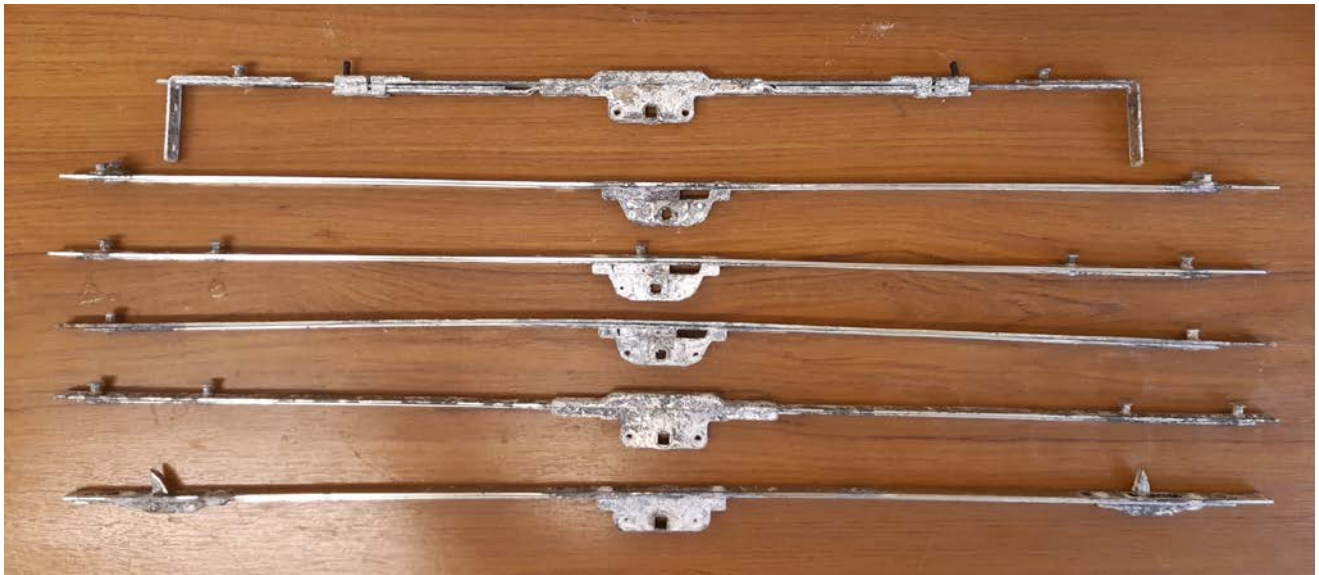
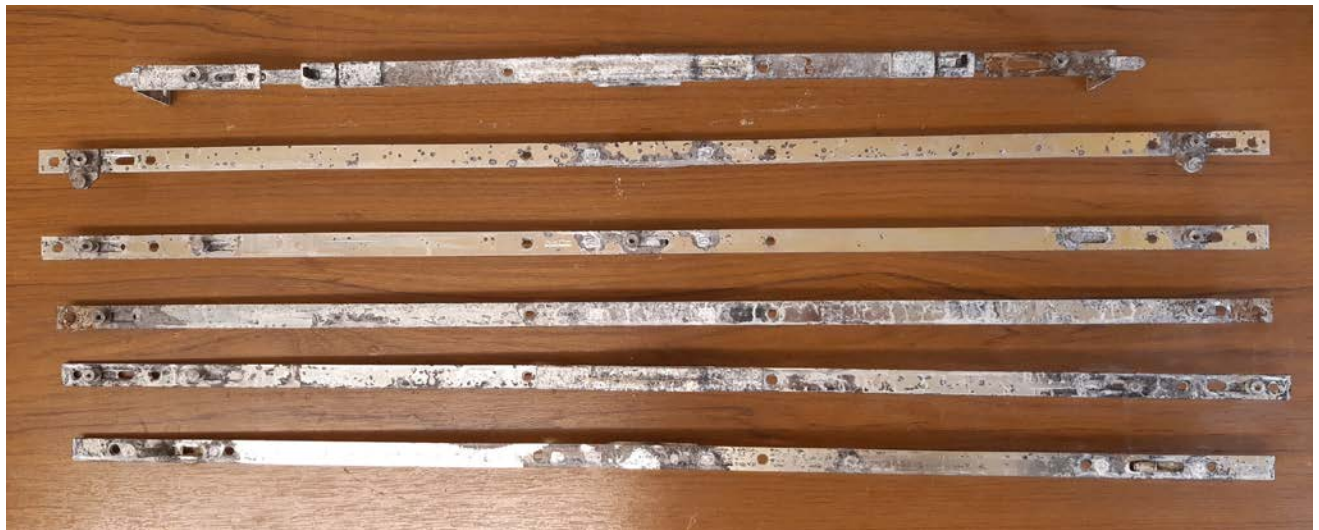
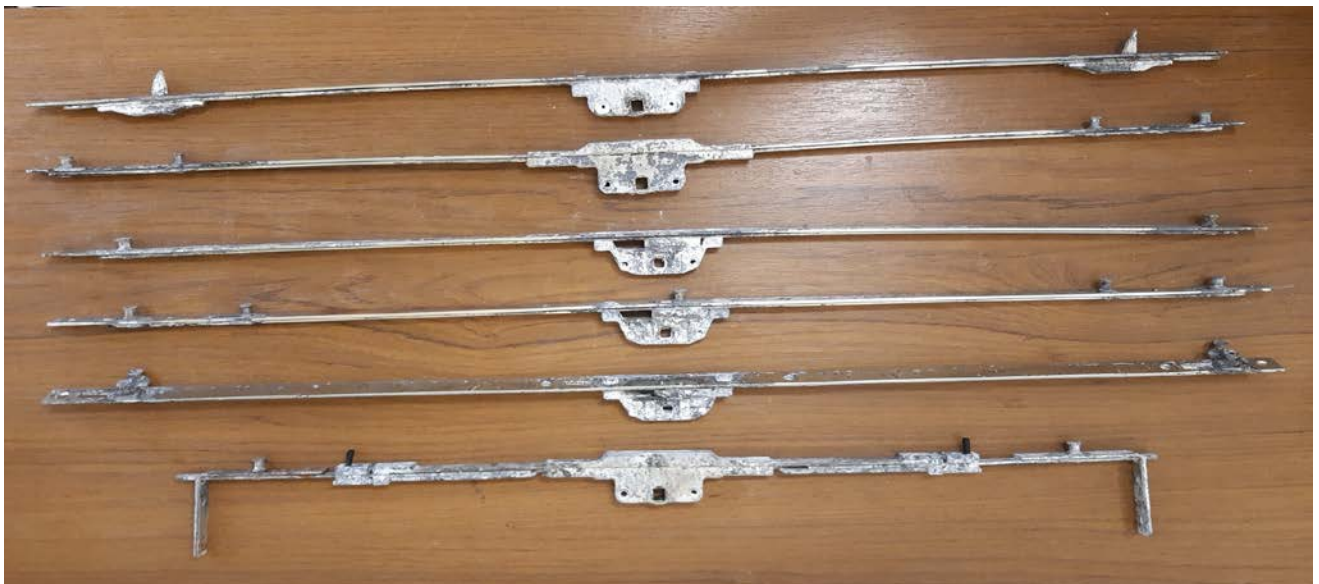
**Samples at 480hrs**

<b>Neutral salt spray exposure</b>	Exposure time	480hrs	Pass
	Condition after test	Some black staining, build up of salt residue around casing	
	Operates satisfactorily	Yes	
	No tarnishing of uncoated surfaces	None	
	No more than 1 spot per 650mm <sup>2</sup> of area on coated surfaces	None

<b>Neutral salt spray exposure</b>	Exposure time	480hrs	Pass
	Condition after test	Significant black staining, build up of salt residue around casing	
	Operates satisfactorily	Yes	
	No tarnishing of uncoated surfaces	None	
	No more than 1 spot per 650mm <sup>2</sup> of area on coated surfaces	None

<b>Neutral salt spray exposure</b>	Exposure time	480hrs	Pass
	Condition after test	Some black staining, build up of salt residue around casing	
	Operates satisfactorily	Yes	
	No tarnishing of uncoated surfaces	No	
	No more than 1 spot per 650mm <sup>2</sup> of area on coated surfaces	None
