Test Report No: WTH 1614-1
Date: 08/12/2016
Testing of: Side hung next to side hung projecting
Casement window
Tested to: PAS 24 : 2016
Prepared for: Nico Manufacturing Ltd

Description	Side hung next to side hung
Model / type	Projecting casement window
Make / Brand	Veka 70
Date sample received	17/11/2016
Any special requirements	None

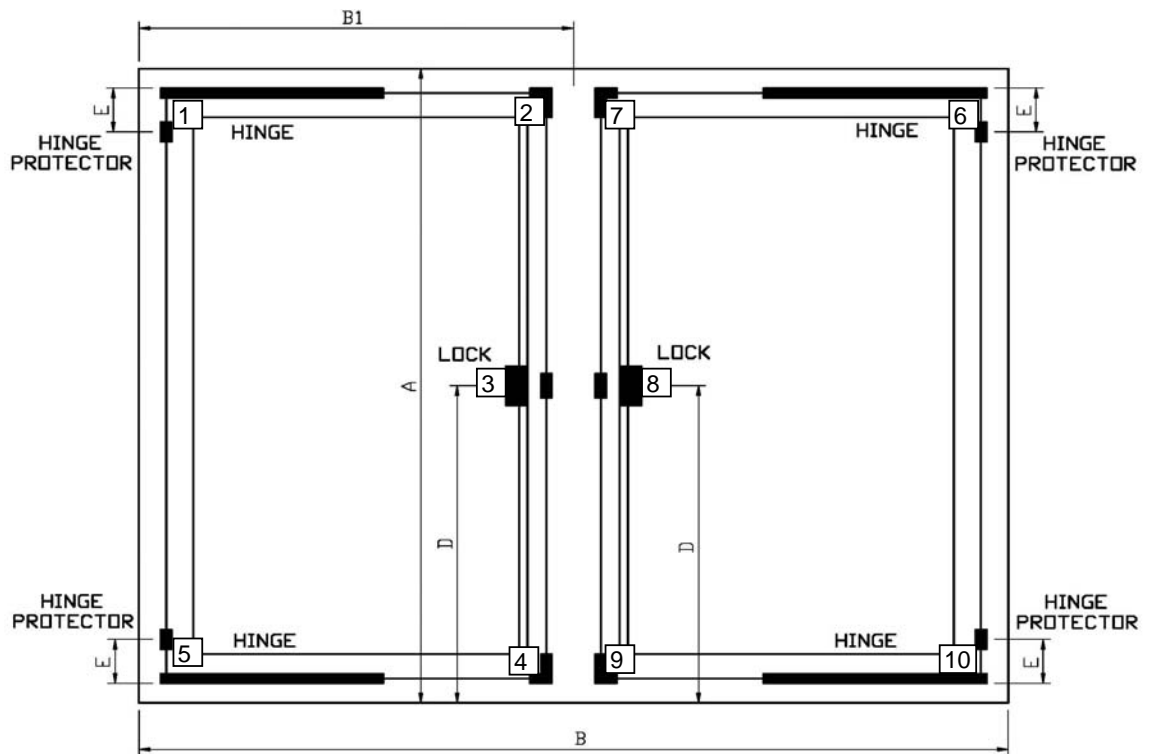
TEST WINDOW DRAWING

- A = 1200 mm
- A1 = mm
- B = 1200 mm
- B1 = 600 mm
- C = mm
- D = 600 mm
- E = 85 mm

C.4.5 Mechanical loading test. - Loading consists of the application of a 1000N parallel to plane load which is held until a 3000N perpendicular to plane load has been applied and removed. Loads are applied to each corner and at each locking and hinge point of each opening sash. Loading cases (table C.1) and sequence of loading (figure C.14) are shown in PAS 24:2016.

Laboratory conditions	Temperature	18.9°C	Humidity	37%RH	Date	08/12/2016
Load location	Parallel to plain load		Perpendicular to plain load		Observations / Assessment	
1 Top hinge & hinge protector L/H sash Vertically down	1000 N (10 sec)		3000 N (10 sec)		Held for 10 sec sash deflected until hinge protector engaged	
1 Top hinge & hinge protector L/H sash Horizontal	1000 N (10 sec)		3000 N (10 sec)		Held for 10 sec No further damage	
2 Top lock corner & shootbolt L/H sash Vertically down	1000 N (10 sec)		3000 N (10 sec)		Held for 10 sec No visible damage	
2 Top lock corner & shootbolt L/H sash Horizontal + mullion pull	1000 N (10 sec)		3000 N (10 sec)		Held for 10 sec No visible damage	
3 Centre locking cams L/H sash Vertically down	1000 N (10 sec)		3000 N (10 sec)		Held for 10 sec No visible damage	
3 Centre locking cams L/H sash Horizontal + mullion pull	1000 N (10 sec)		3000 N (10 sec)		Held for 10 sec No visible damage

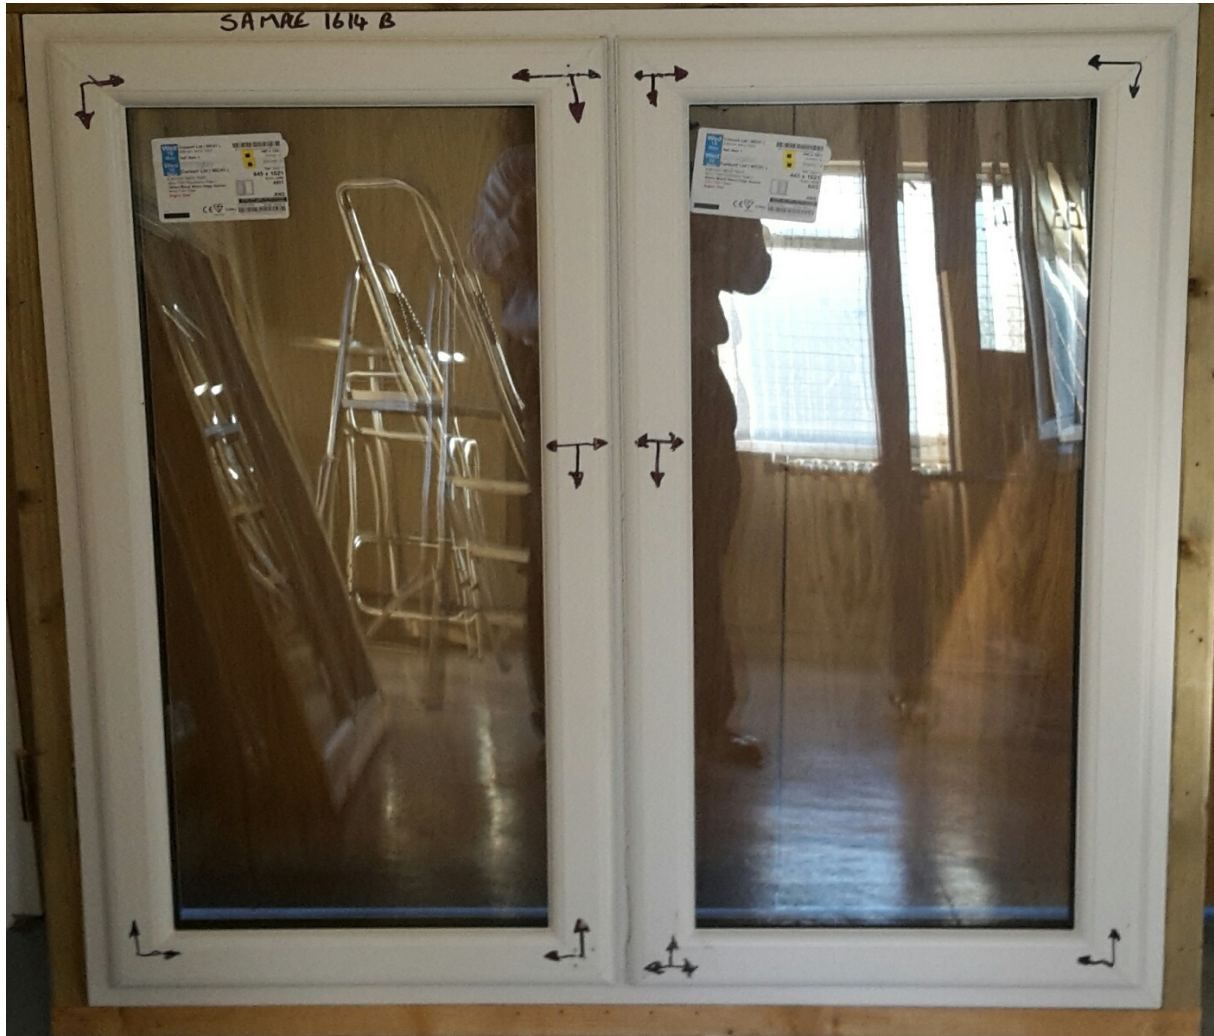
PICTURE OF TEST WINDOW

Sample details	Side hung next to side hung projecting casement window
Fabricator	Consort Ltd
Material:	PVC-U, fully welded joints Frame - Veka profile part no 101160 Sash - Veka profile part no 103264 Mullion - Veka profile part no 102261 Reinforcing; Only present in mullion, Veka part no 113041
Finish	White
Lock & keeps	Lock - Nico Telescopic Shootbolt, part no 979111422 keeps - Cast zinc, part nos; Espag keep 9003, corner keep 93K1
Hinges & protectors	Hinges - Nico 16" standard 13mm friction hing, part no 7740 Hinge protectors - Part no 8000
Handle	ERA Maxim 3, L/H & R/H cranked
Fixings	Lock; 3.9 x 30mm c'sk head pierce point Keeps; 4.3 x 25mm c'sk head pierce point to front position, 3.9 x 25mm c'sk head drill point to rear position. Hinges; 4.3 x 25mm pan head pierce point to sash and frame Hinge protectors; 4.3 x 25mm pan head pierce point to sash and frame
Weather sealing	Co-extruded epdm gasket.

Glass (or infill)	28mm double glazed sealed unit ,4-20-4mm Toughened glass.
Glazing system	Internally bead glazed Beads have co-extruded EPDM gaskets
Sample dimensions	1200mm (h) x 1200mm (w), central mullion.
Additional information
