Test Report No: WTH1808#1-1 Nico

Testing of: Side hung next to fixed light projecting casement window

Tested to: PAS 24 : 2016

Prepared for: Nico Manufacturing Ltd

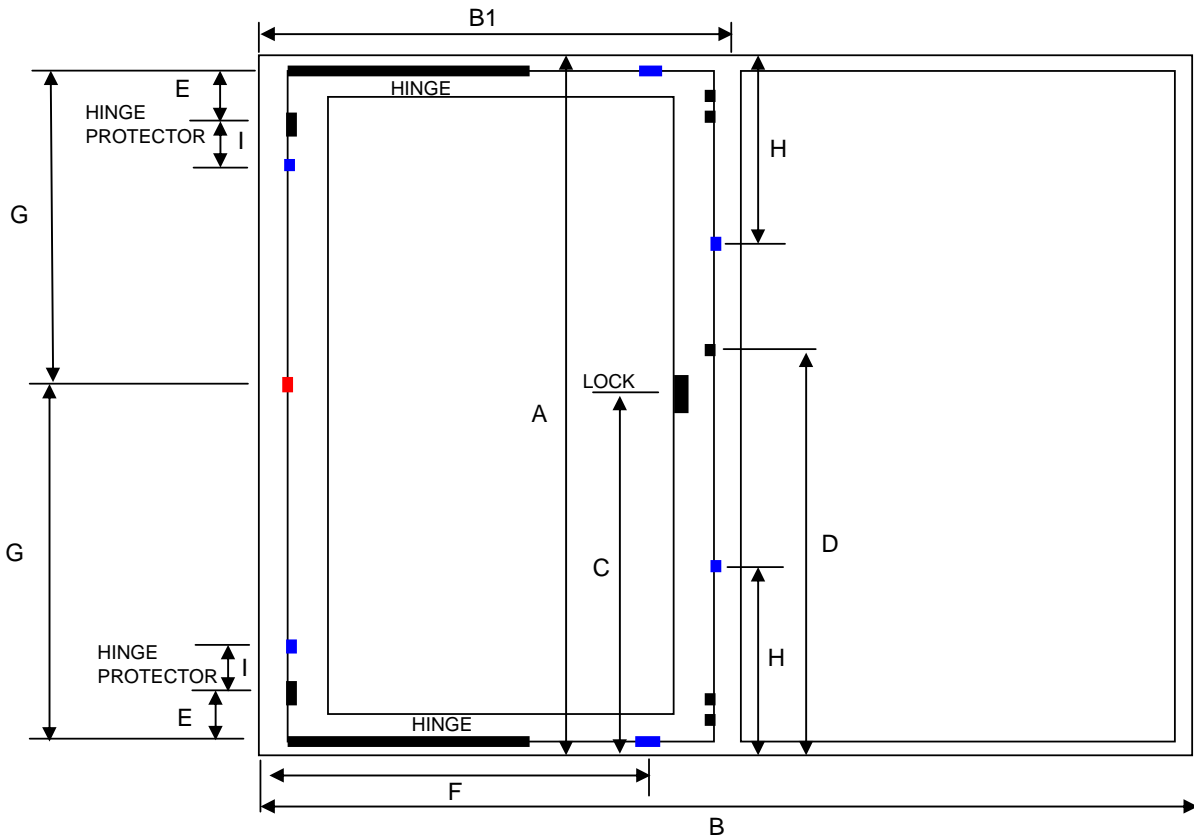
TEST WINDOW DRAWING

- Run up blocks
- Weather wedges

A	=	1300	mm
B	=	1300	mm
B1	=	650	mm
C	=	650	mm
D	=	760	mm
E	=	100	mm
F	=	550	mm
G	=	610	mm
H	=	360	mm
I	=	70	mm

Sample details	Side hung next to fixed light projecting casement window
Fabricator	Affordable Window Systems Ltd
Material:	PVC-U Kommerling O70 profile. Profile nos, Sash - 2917, Frame - 2900, Mullion - 2921 Reinforcing - Steel, supplied by Northwest Metals, part nos Sash - 1369, Frame - 1368, Mullion - 1365
Finish	Gloss white
Lock & keeps	Nico RAM bolt - part no 9591222 Nico cast zinc keeps - part no 9119 at top & bottom, 9019 in centre
Hinges & protectors	Nico Standard 16" Friction hinge - Part no 8240 Hing protectors - Nico Xtra bolt 17mm, part no 8100
Handle	Fab & Fix Connoisseur inline, part no SLG201
Fixings	Lock - M4 x 32mm c'sk head drill point Keeps - M4 x 32mm c'sk head drill point to rear, 4.8 x 38mm c'sk head pierce point to front Hinges - 3.9 x 32mm pan head drill point to frame M4 x 32mm c'sk head drill point to sash Hinge protectors - 3.9 x 32mm pan head drill point to frame M4 x 32mm c'sk head drill point to sash

Weather sealing	Co extruded gaskets
Glass (or infill)	4-20-4 mm double glazed units
Glazing system	Internally bead glazed with co extruded gaskets Glazing beads - Kommerling part no 1933 GT Securi clip part nos - SB000 base plate, GT028 yellow packer, SC121 clip
Sample dimensions	1300mm(h) x 1300mm(w) central mullion
Additional information	Run up blocks - Kommerling part no 7199
