Test Report No: WTH1910#3-1

Testing of: Single top hung flush casement window

Tested to: PAS 24 : 2016

Prepared for: Nico Manufacturing Ltd

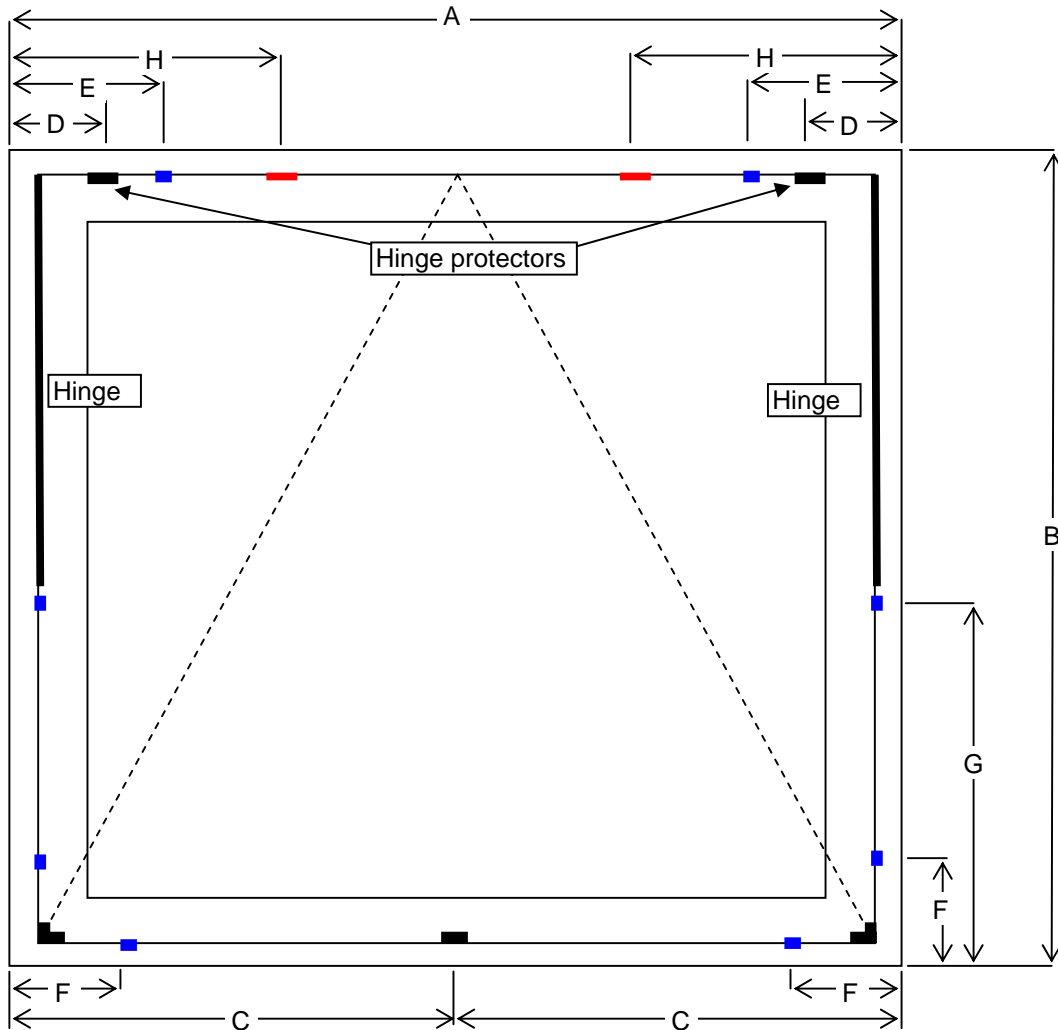
**TEST WINDOW DRAWING**

■ Run up blocks  
■ Weather wedges

- A = 1200 mm
- B = 1200 mm
- C = 600 mm
- D = 125 mm
- E = 200 mm
- F = 150 mm
- G = 530 mm
- H = 360 mm
