Test Report No: WTH2309#2-1

Testing of: Side hung next to fixed light casement window

Tested to: PAS 24 : 2022

Prepared for: Nico Manufacturing Ltd

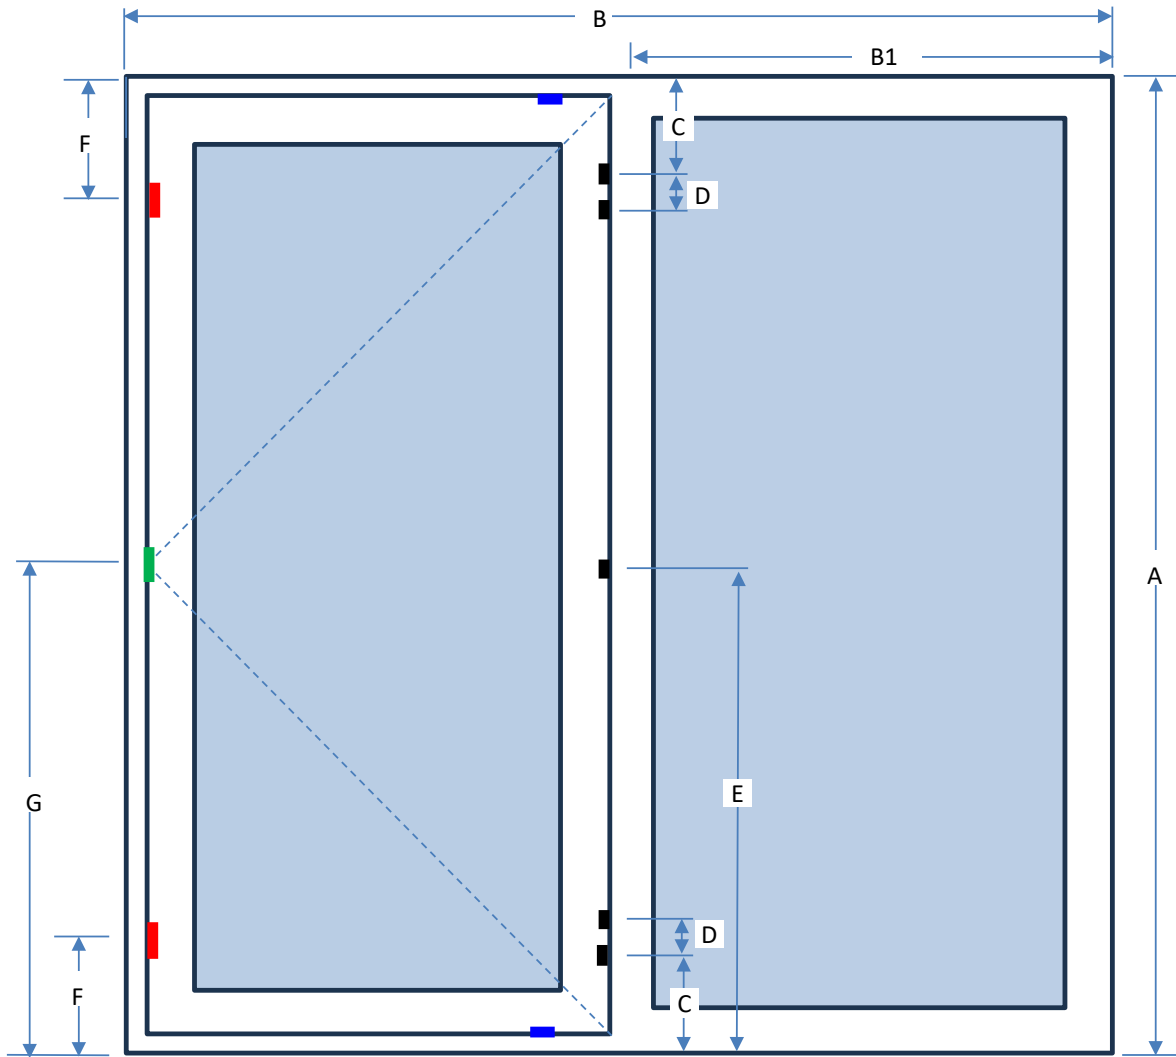
**TEST WINDOW DRAWING**

- Hinge protector
- Interlocking wedges
- Lock point
- Riser block

- A = 1070 mm
- B = 1000 mm
- B1 = 500 mm
- C = 100 mm
- D = 170 mm
- E = 535 mm
- F = 120 mm
- G = 535 mm
