Test Report No: WTH2403#2-1 Rev 1

Testing of: Side hung by side hung casement window

Tested to: PAS 24 : 2022

Prepared for: Nico Manufacturing Ltd

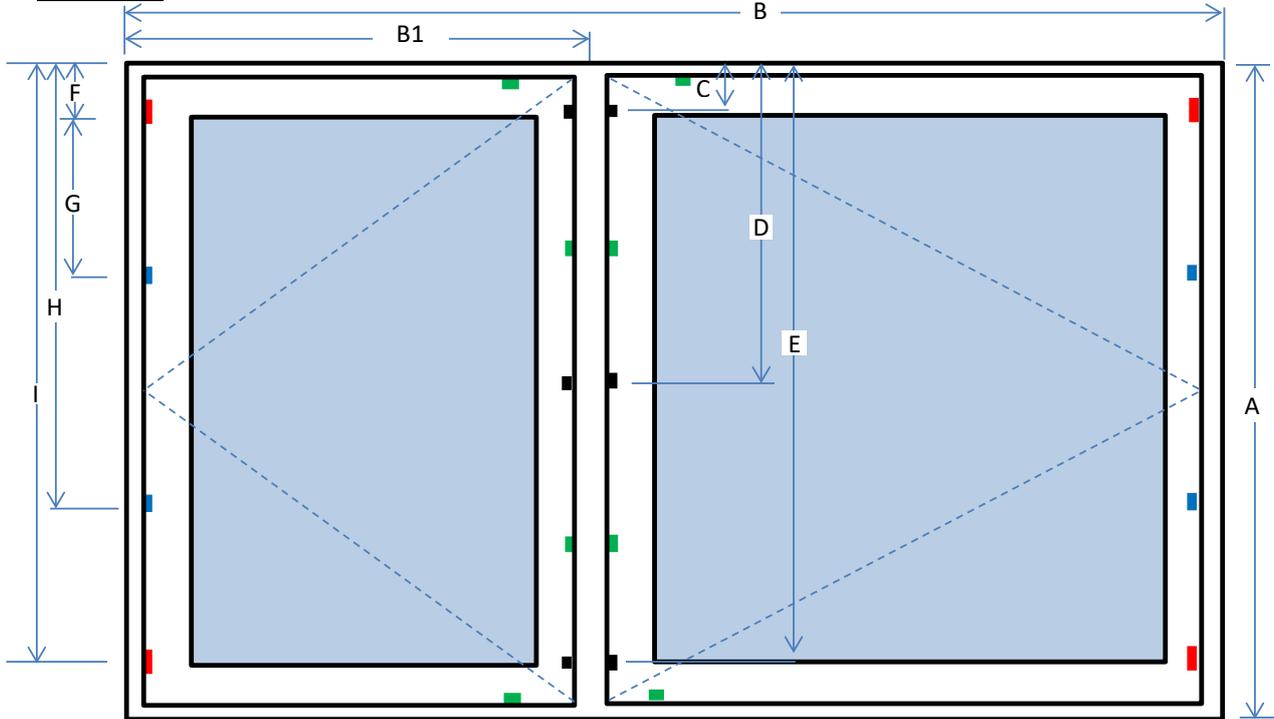
- █ Hinge protectors
- █ Riser block
- █ Pull in wedge
- Lock point

A	=	1470	mm
B	=	1678	mm
B1	=	739	mm
C	=	95	mm
D	=	730	mm
E	=	1360	mm
F	=	90	mm
G	=	405	mm
H	=	975	mm
I	=	1380	mm

Sample number	WTH2403A
Sample details	Side hung next to side hung casement window
Fabricator	Quantum Windows Ltd
Material:	PVC-U, Eurocell Modus profile Eurocell part numbers; Frame - LSF1021W, Sash - LSF1005W, Transom/Mullion - LSF1002W, Transom/Mullion reinforcement - EWS801P
Finish	Gloss White
Lock & keeps	Lock - Nico PAS Espag, part no 9291422 Keeps - Nico PAS Espag Keep, part no 9205L/R
Hinges & protectors	Hinges (large sash) - Nico 17mm Atlas Quad, part no 8471L and Nico 17mm stack 14" Atlas, part no 8571R. Hinges (Small sash) - 16" Standard, part no 8240L and 16" Standard Restrictor, part no 8340R. Hinge protectors - Nico Xtra bolt, part no 8100
Handle	Fab & Fix inline white
Fixings	Lock - 4.3 x 25mm c'sk head pierce point Keeps - 4.3 x 25mm c'sk head pierce point Hinges - 4.3 x 30mm c'sk head pierce point to sash, 4.2 x 21mm pan head pierce point to frame Hinge protectors - 4.3 x 30mm c'sk head pierce point Weather interlock wedges - 4.3 x 25mm c'sk head pierce point

Weather sealing	Co extruded gaskets Interlocking wedges, part no EWS7201W
Glass (or infill)	4-20-4mm clear toughened double glazed units
Glazing system	Co extruded gaskets Internally bead glazed - LSF1301W
Sample dimensions	1470mm (h) x 1678mm (w), mullion 739mm
Additional information	Clip in leading ramp - LSF1202W

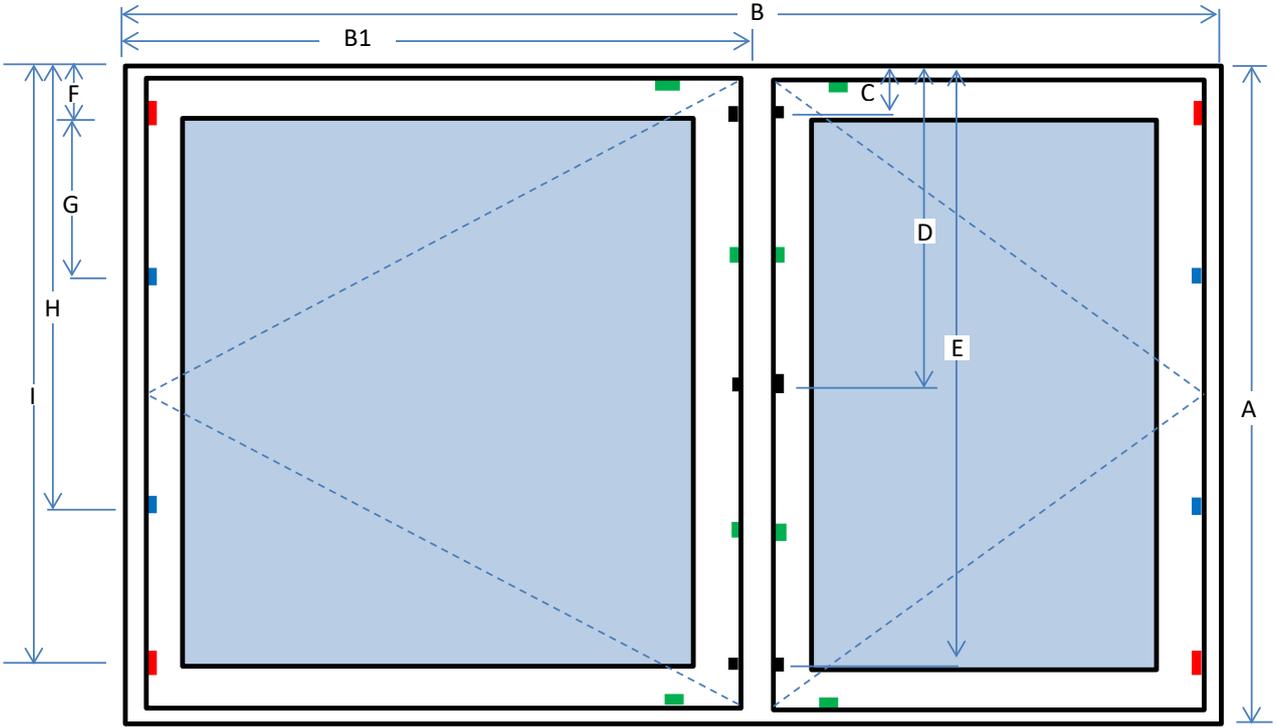
- Hinge protectors
- Riser block
- Pull in wedge
- Lock point

A	=	1470	mm
B	=	1678	mm
B1	=	939	mm
C	=	95	mm
D	=	730	mm
E	=	1365	mm
F	=	95	mm
G	=	395	mm
H	=	975	mm
I	=	1370	mm

Sample number	WTH2403B
Sample details	Side hung next to side hung casement window
Fabricator	Quantum Windows Ltd
Material:	PVC-U, Eurocell Modus profile Eurocell part numbers; Frame - LSF1021W, Sash - LSF1005W, Transom/Mullion - LSF1002W, Transom/Mullion reinforcement - EWS801P
Finish	Gloss White
Lock & keeps	Lock - Nico PAS Espag, part no 9291422 Keeps - Nico PAS Espag Keep, part no 9205L/R
Hinges & protectors	Hinges - Nico 17mm Atlas Quad on small sash, part no 8471L and Nico 17mm stack 14" Atlas for other 3 hinges, part no 8571L/R Hinge protectors - Nico Xtra bolt part no 8100
Handle	Fab & Fix inline white
Fixings	Lock - 4.3 x 25mm c'sk head pierce point Keeps - 4.3 x 25mm c'sk head pierce point Hinges - 4.3 x 30mm c'sk head pierce point to sash, 4.2 x 21mm pan head pierce point to frame Hinge protectors - 4.3 x 30mm c'sk head pierce point Weather interlock wedges - 4.3 x 25mm c'sk head pierce point

Weather sealing	Co extruded gaskets Interlocking wedges, part no EWS7201W
Glass (or infill)	4-16-4-16-4mm clear toughened triple glazed units
Glazing system	Co extruded gaskets Internally bead glazed - LSF1302W
Sample dimensions	1470mm (h) x 1678mm (w), mullion 939mm
Additional information	Clip in leading ramp - LSF1202W
