Test Report No: WTH2404#6-1

Testing of: Single Top Hung Casement

Tested to: PAS 24 : 2022

Prepared for: Nico Manufacturing Ltd

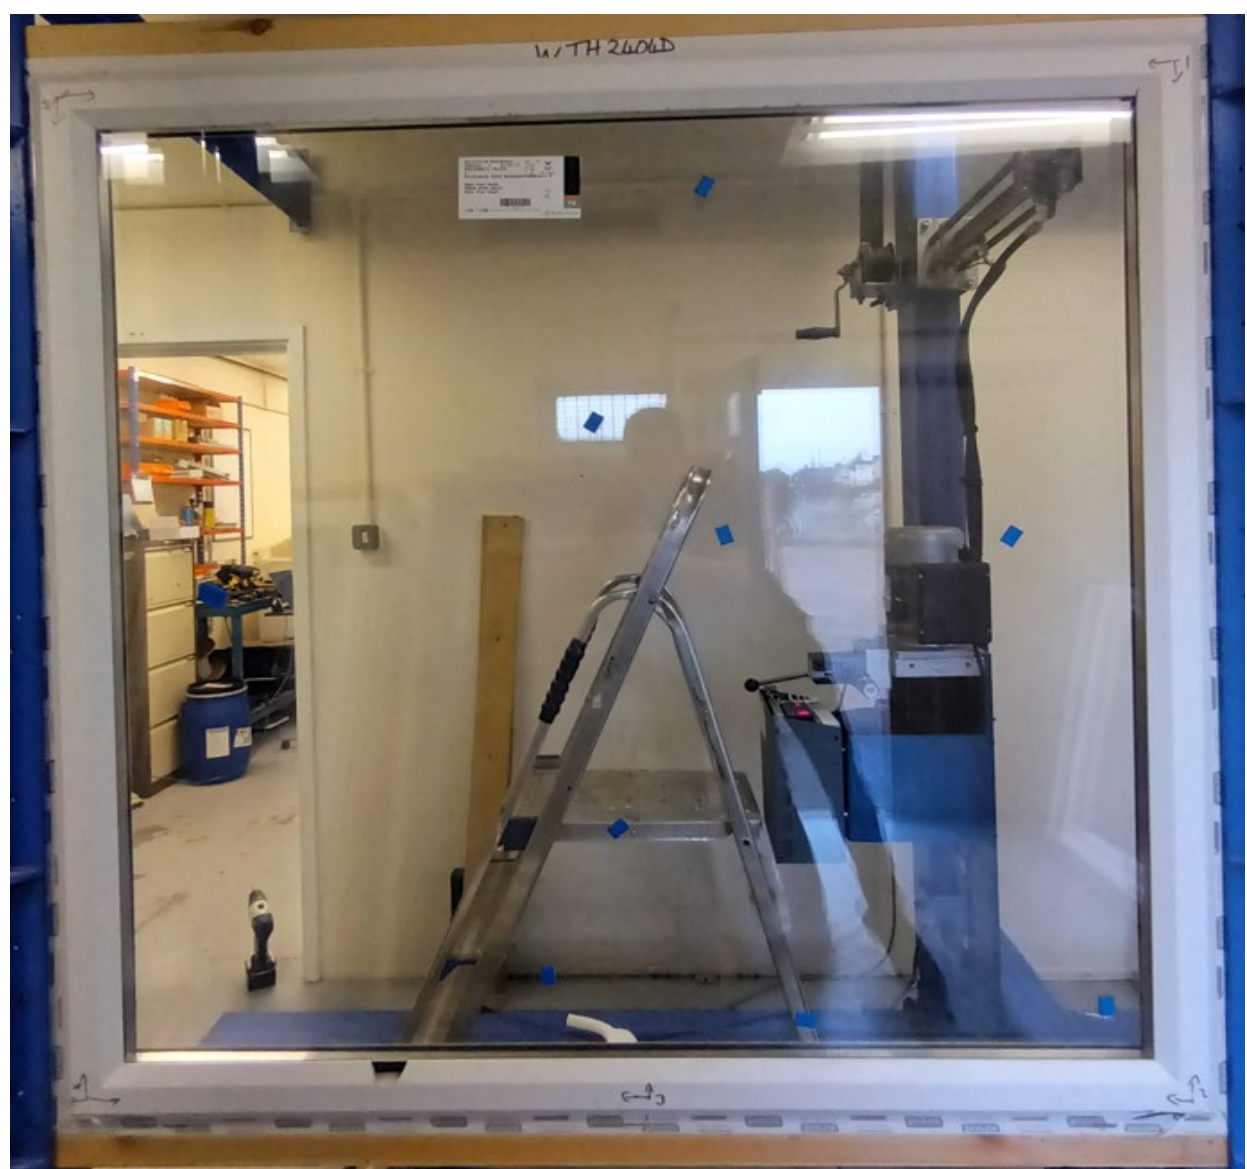
PICTURE OF TEST WINDOW

Sample details	Single Top Hung Casement
Fabricator	Quantum Windows Ltd
Material:	PVC-U, Eurocell logic profile Eurocell part numbers; Frame - EWS7011W, Sash - EWS7008W,
Finish	Gloss White
Lock & keeps	Lock - Nico PAS Espag, part no 9291422 Keeps - Nico PAS Espag Keep, part no 9205L
Hinges & protectors	Hinges - Nico 17mm 24" Heavy Duty Restrictor, part no 8360HDL and 17mm 24" Heavy Duty, part no 8260HDR Hinge protectors - Nico Xtra bolt, part no 8100
Handle	Fab & Fix inline white
Fixings	Lock - 4.3 x 25mm pan head pierce point Keeps - 4.3 x 25mm pan head pierce point Hinges - 4.3 x 30mm c'sk head pierce point to sash, 4.3 x 21mm pan head pierce point to frame Hinge protectors - 4.3 x 30mm c'sk head pierce point Weather interlock wedges - 4.3 x 25mm c'sk head pierce point
Weather sealing	Co extruded gaskets Interlocking wedges, part no EWS7201W
Glass (or infill)	4-20-4mm clear toughened double glazed units

Glazing system	Co extruded gaskets Internally bead glazed, part no LSF1301W
Sample dimensions	1470mm (h) x 1475mm (w)
Additional information	Clip in leading ramp, part no LSF1202W
